**Submitted to the
Town of Dedham, Massachusetts**

GLENWAY/HAMILTON AVENUE STUDY AREA

Final Report

April 2004

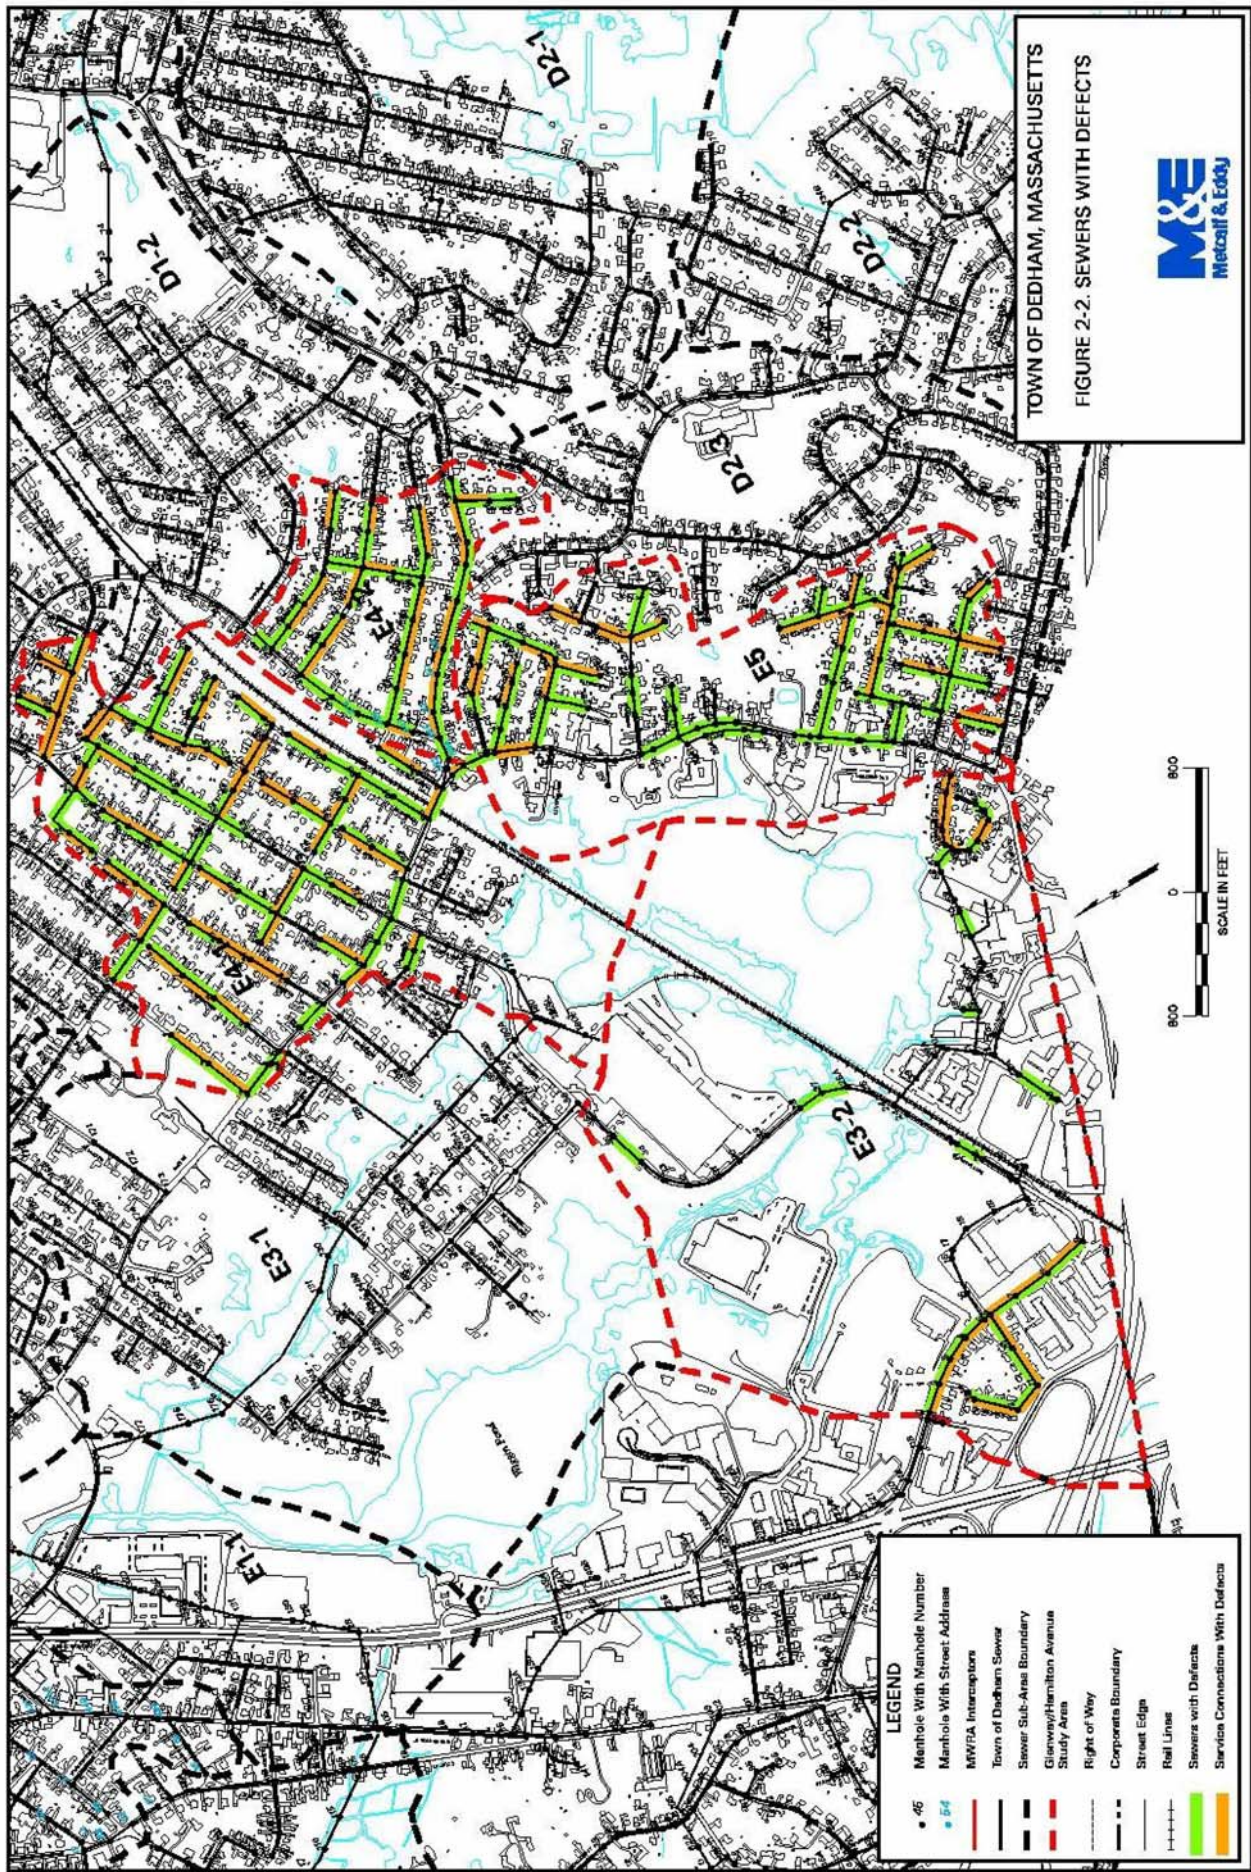
Table 2-4 also includes a column that categorizes the severity of defects observed within each sewer pipeline as minor, moderate, or major. Sewer pipelines with minor defects would generally include roots and leaky joints that may be addressed by performing chemical treatment for root control and joint testing and sealing. Sewer pipelines with moderate defects would generally include roots, leaky joints, and minor cracked pipe that may be addressed by performing the aforementioned methods as well as spot repairs with chemical grout or the installation of a short structural liner. Sewer pipelines with major defects would generally include cracked or broken pipe throughout the length of the sewer pipeline that may be address by relining or dig-and-replacement of the existing pipe. Specific recommendations on the rehabilitation of the sewers in the study area are presented in Section Four of this report.

As shown by the highlighting in Table 2-4, there are a number of sewers where replacement work will be performed under the proposed Glenway/Hamilton Avenue construction contract or where rehabilitation work has already been performed by the town since the time the original TV inspection work was conducted. In addition, there are a number of sewers that could not be fully inspected due to root blockages, collapsed pipe, protruding service connections, or severe pipe sags that blocked the progression of the camera. This is noted in the defect severity column of Table 2-4 where sewers that could not be fully inspected are labeled as incomplete. These sewers require repairs such as root treatment, cutting back a protruding service connection, or replacement of a collapsed section to open the line to allow for the passage of the television camera to complete inspection of the line. Where appropriate, recommendations to this effect have been included in Section Four of this report.

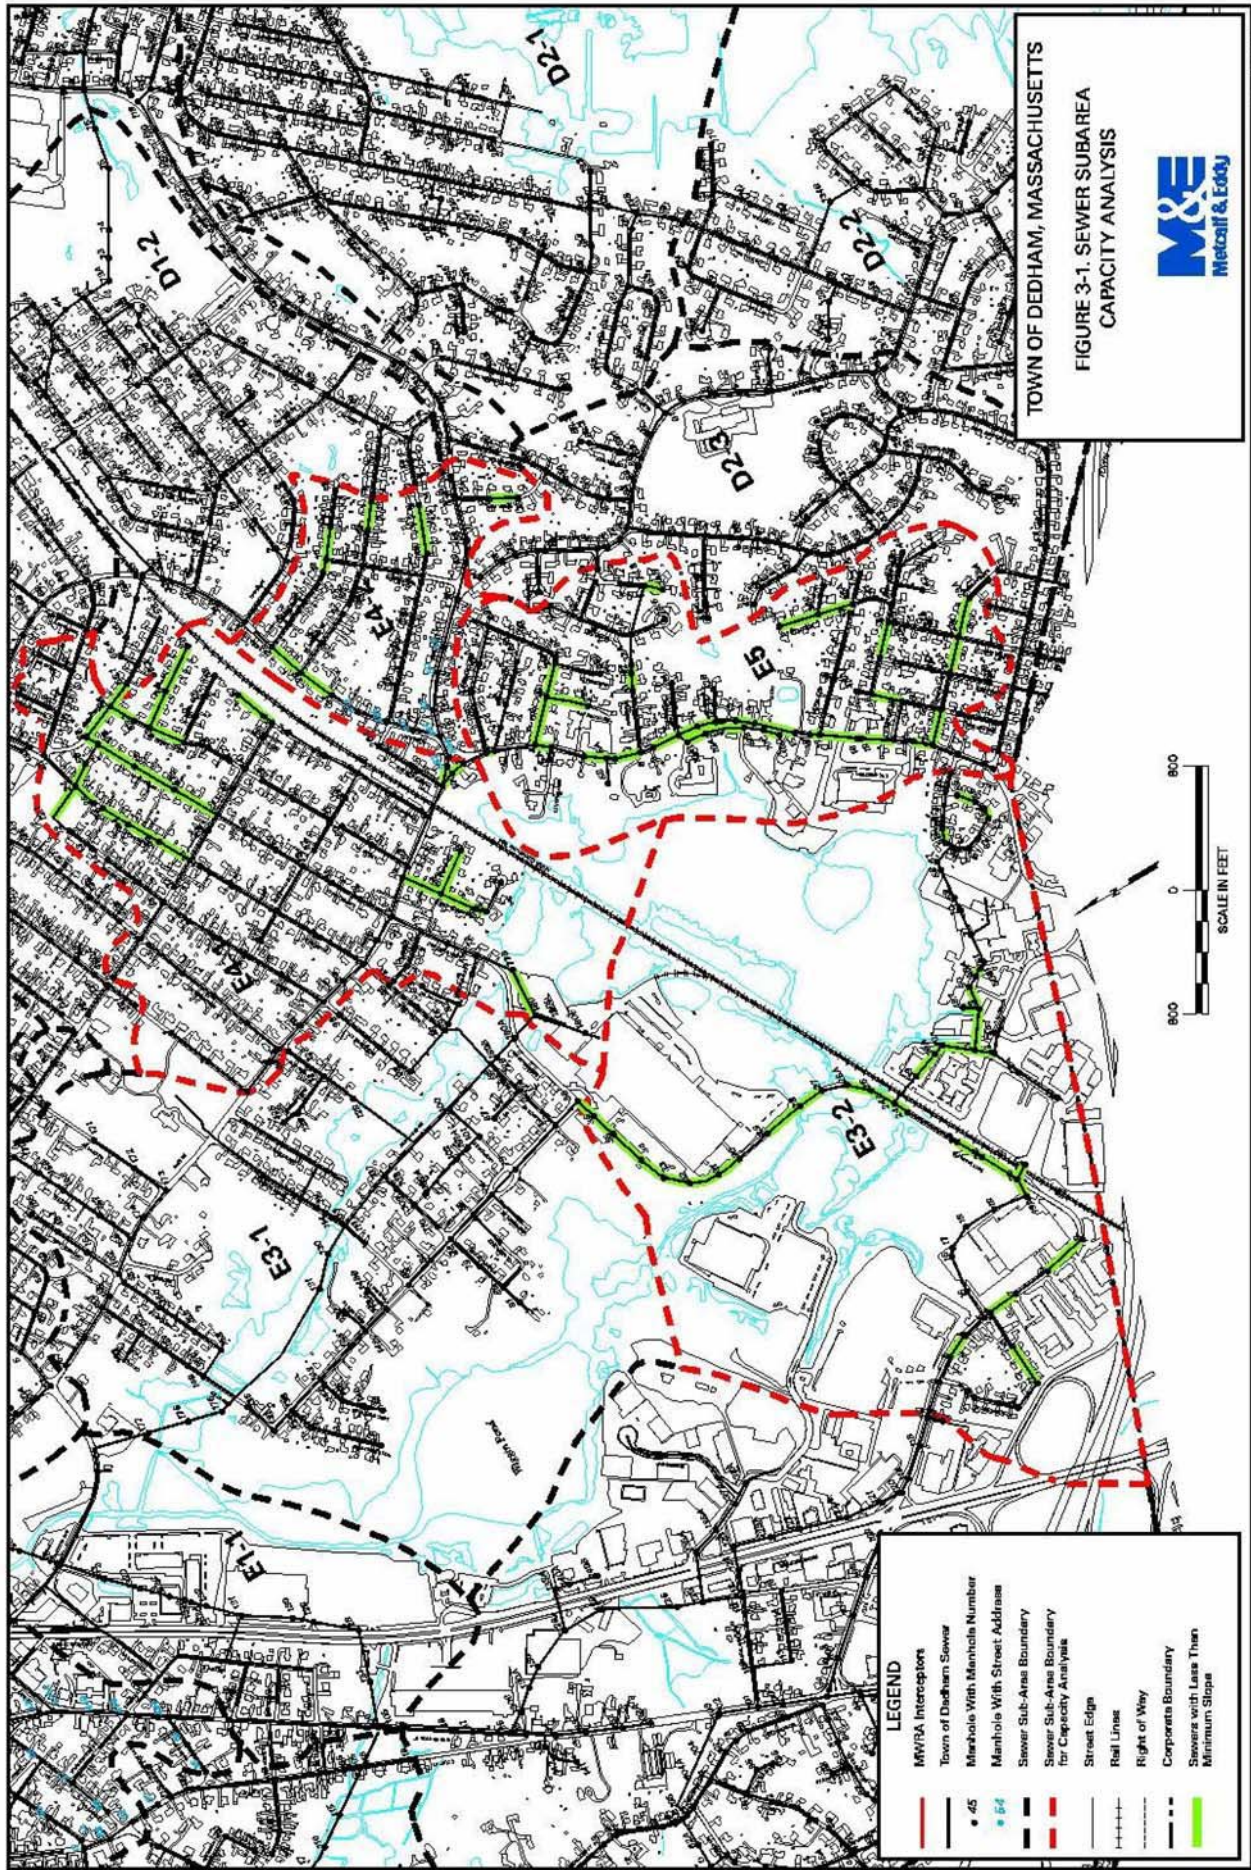
The TV inspection of this sewer also identified multiple sags throughout its entire length. According to record plan information, a portion of the existing sewer was constructed on a pile foundation which suggests that poor soil conditions exist in the area. This is further supported by the fact that a significant portion of the EBRI was constructed on pile foundations due to the poor soil conditions observed along the project corridor between Rustcraft Road and Eastern Avenue.

Finally, based on comparison of the rim and invert elevations, there are sections of the existing sewer that have less than two feet of cover. In comparison, new sewers located in paved roadways are generally designed with seven feet of cover, with a minimum of six feet typically required. The existing sewer on Rustcraft Road may be an example of where the installation of a pump station and force main may have been more appropriate due to the relatively flat topography and poor soil conditions within the area. Although it should be noted that the town of Dedham's sewer system operates entirely by gravity, as a result of performing work throughout the system, there are several areas where a pump station and force main could have been constructed to minimize the potential for flow related problems to occur. Section Four of this report evaluates the alternatives available to the town in addressing problem areas such as the existing sewer along Rustcraft Road.
